Evaluation of Crack Sealing Compounds for Asphaltic Pavements

EMO PROJECT NO. 33

Final Report

Oct. 1983

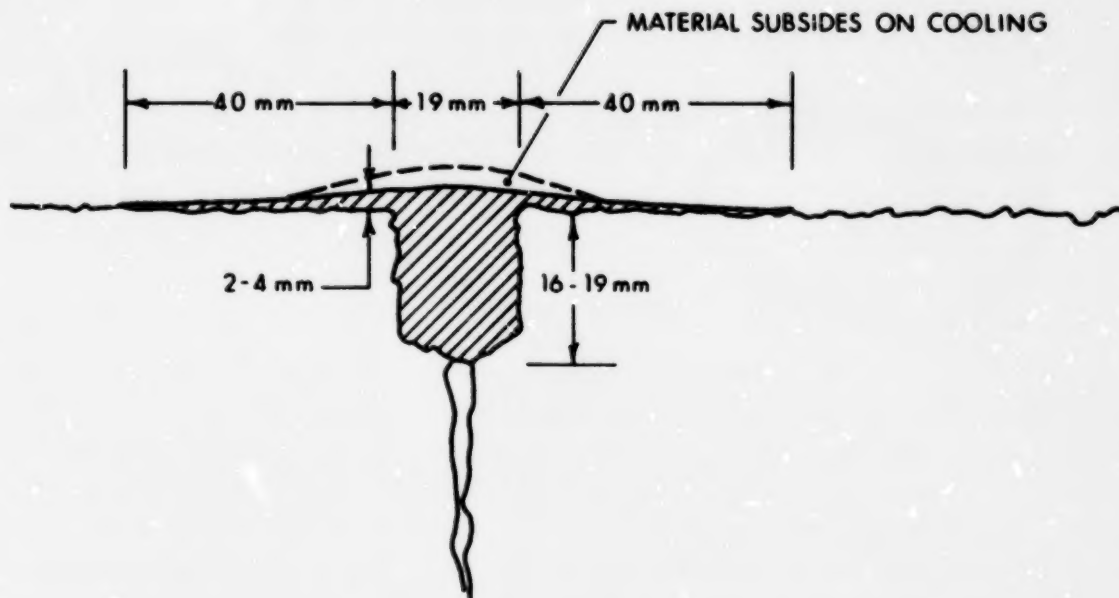
FIGURE 2

The desired cross section of seal in a routed groove is as shown in Figure 2. Most of the strike off devices used just levelled the sealant but the "U" and "V" shaped squeegees with a crescent cut out of the rubber at the back gave the desired cross section to the sealant. The sealant needs to be struck off so as to leave a bead of material over the routed groove with the edges of the material feathered out. The bead of material will flatten out considerably after subsiding into the crack and through thermal shrinkage. If the sealant stands too proud of the surface, it is subject to snow plough damage. Due to either inappropriate strike off devices or lack of operator skill, lumps of sealant were left proud of the pavement surface at the ends of cracks or where a crack changed direction. This material created a noticeable bump which will likely be cut off in the winter by snow plowing operations, with the risk that additional material may be pulled out of the sealed crack.

DESIRED CROSS-SECTION OF ROUTED AND SEALED CRACK

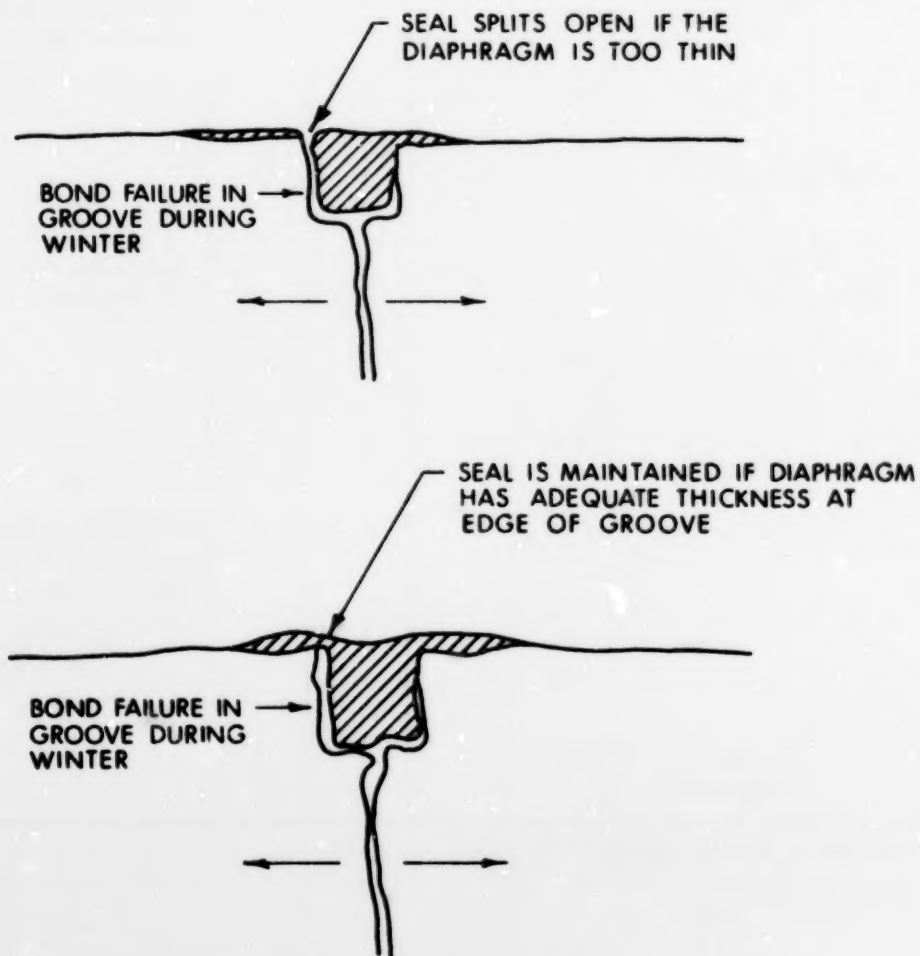
FIGURE 3

During the four appraisals it became evident that splitting of the seals at the edge of the rout was minimized if the membrane at that point had a 2-3 mm cross-sectional thickness. Where the sealant was struck off thin, (less than 1 mm) poor performance was common. In several sections it was noted that an effective seal was maintained even though the material was no longer bonded in the routed groove as confirmed by pinching the seal between thumb and forefinger and lifting it up and down. This occurred when the diaphragm across the rout had enough cross-sectional area to maintain its integrity. Figure 3 indicates how the cross-section of the seal can affect winter performance.

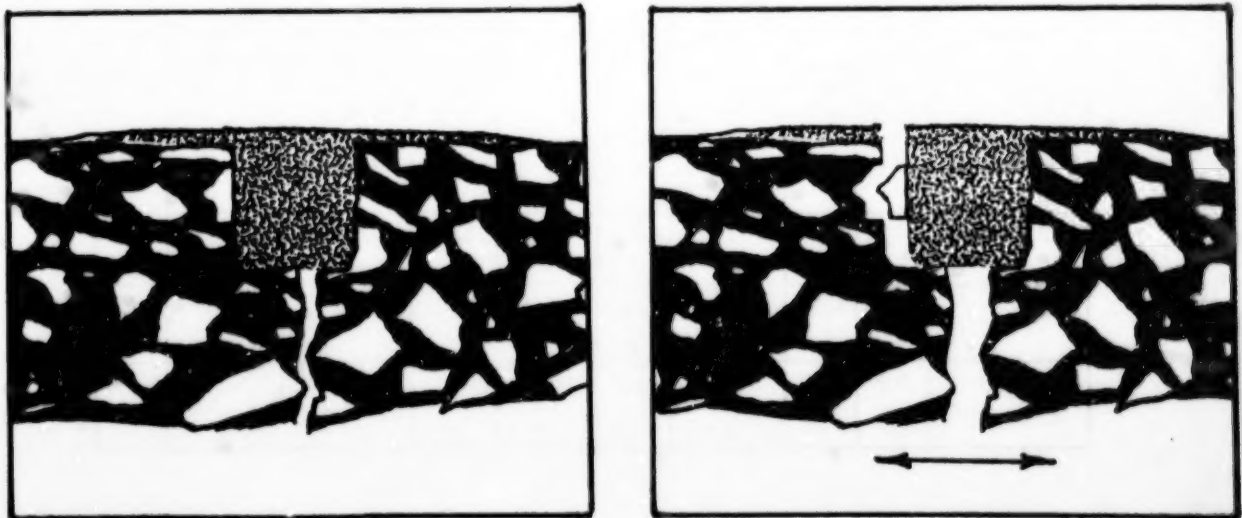
FIGURE 4
GENESIS OF A "BOND" FAILURE

The work in 1981 and 1982 established that seals fail primarily in bond and that if moisture was present at the time of routing and sealing, bond failure was almost assured. To clarify, separation or splitting of a seal at the edge of the routed groove has been identified as a bond failure. This is a somewhat oversimplified description because the actual failure may be a combination of bond/cohesive failure plus a partial failure of the pavement. Sealants with a good bond and high stiffness modules will pull aggregate that have been disturbed in the cutting operation out of the side of the routed groove. This was observed in many of the test sections. Figure 4 demonstrates how a "bond" failure may be a combination of failures.

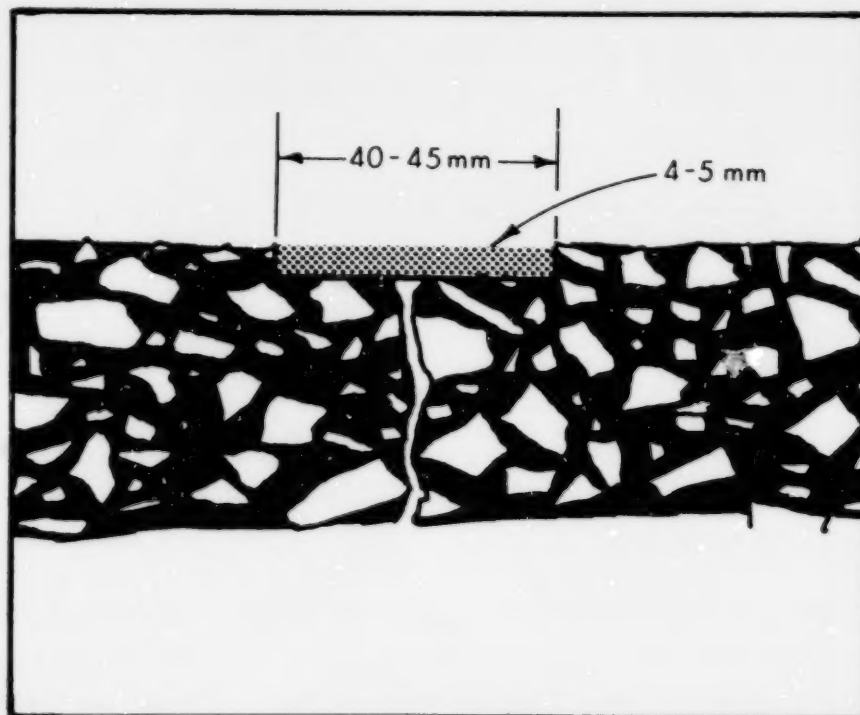
FIGURE 4

Several trial installations have been constructed in 1983 using a method introduced to the Ministry by Klaruw of Holland (Fig.4). This method has the advantage of the overband seal without the hazard of snow plow damage. These installations will be reviewed over the winter of 83-84.

KLARUW METHOD
